Subject: Lower Middle Fork Nooksack Geomorphic & Hydraulic Assessment

Middle Fork Nooksack River LWD Preliminary Design

MIDDLE FORK NOOKSACK LWD DESIGN RMO. S.O.

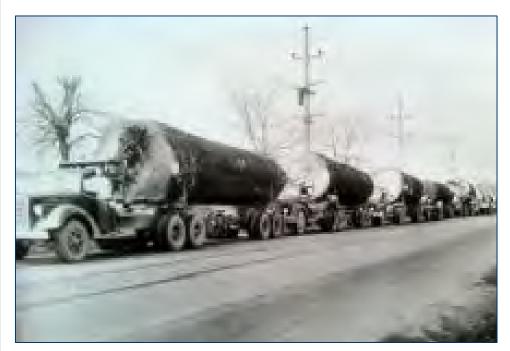
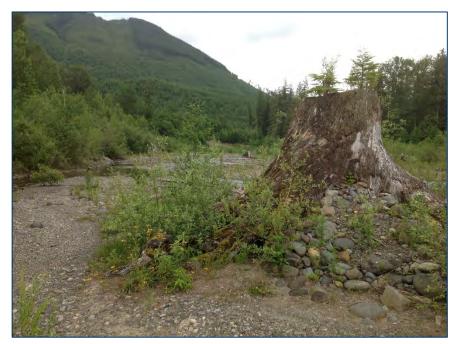
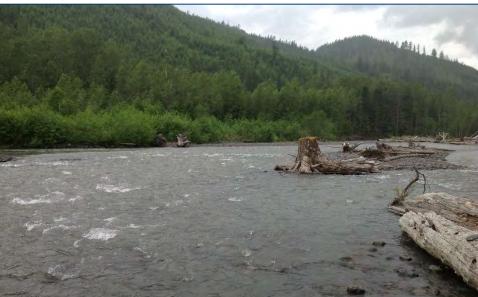
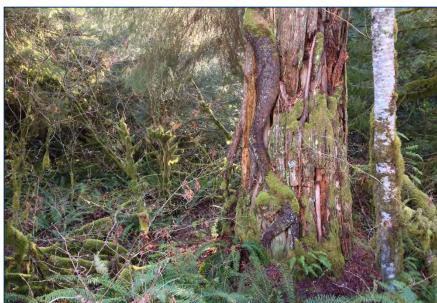
FIGURE 2 – Historic harvest of large diameter timber in the Nooksack basin (Top left, Whatcom County Museum); large stump in Porter Creek channel near RM 4.3 (Top right); LWD at RM 3.5 (Lower left); and old growth stump in right bank floodplain near RM 5 (Lower right)

The primary disturbance to the project reach impacting salmonid habitat is that from historic logging of the floodplain forest and adjacent hillslopes (LNRD 2011). Logging activities that contribute to salmonid habitat degradation include destabilization of the landscape from loss of soil root cohesion, reduction in LWD loading from removal of large trees from floodplain forests and clearing of LWD from the channel. The original old growth forest of the valley included huge Cedar, Douglas Fir, Western Hemlock, Grand Fir, Big Leaf Maple, and Black Cottonwood that attained diameters well over 6-ft and heights of more than 200-ft. These large riparian trees created stable snags when they fell into the river, that immediately formed stable habitat or went on to accumulated mobile LWD, creating larger logiams capable of re-directing the river. Timber harvests began in the late 19th century when logging practices included clearing trees on riparian floodplains and unstable steep slopes (LNRD 2011). Multiple large conifer stumps (>6-ft in diameter) were observed throughout the current active channel (active channel is the area of exposed and unvegetated alluvial deposits) and floodplain (Figure 2). Cut marks for springboards observed on many of the stumps observed during the field reconnaissance suggest the largest "key-sized" timber was removed in the early 1900's. Industrial logging continues within the watershed presently but current regulations are in place to limit harvest on streambanks, channel migration zones, floodplains, or unstable slopes. The impacts from these historic disturbances are recorded throughout the project reach and are associated with:

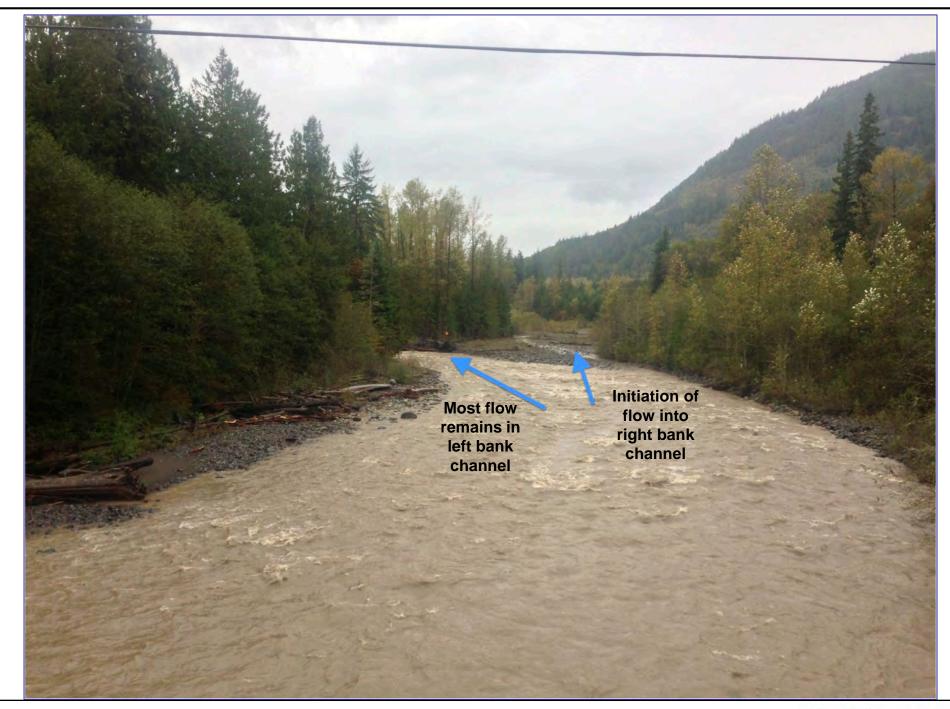
FIGURE 3 – Flow split at RM 4.9 at 1,600 cfs.

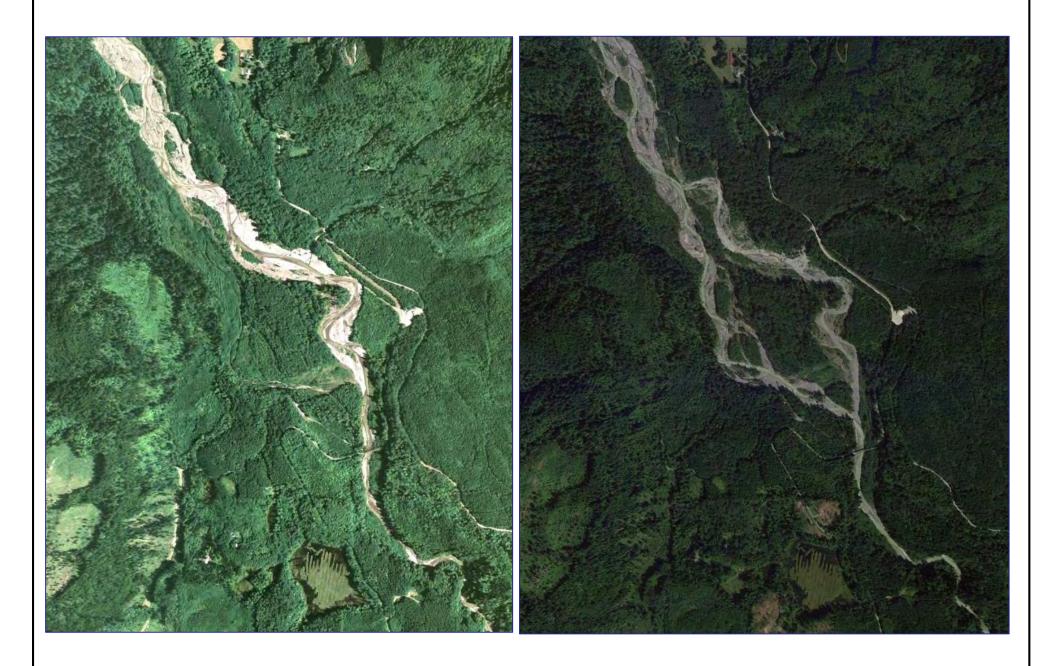
FIGURE 4 – Channel Avulsion between RM 3.9 - 4.8; 2005 (left) to 2011 (right).

A second project was constructed in 2010 at 3 locations along the Middle Fork (Figure 1). Approximately 200 conifer logs ranging from 2- to 3-ft DBH and 30- to 40-ft long with rootwads were helicopter placed in the left bank channel (post avulsion) from RM 4.6 to 4.8, and in the right bank channel (old main channel) from RM 3.9 to 4.5. An excavator was used to place the new key logs and 1-ft diameter, 16-ft long driven piles (8- to 10-ft depth) to secure existing LWD accumulations and create new LWD accumulations. New LWD accumulations consisted of 6- to 10-pieces, with some secured using 2-in diameter manila rope. Additional new structures were installed along the right bank from RM 2.9 to 3.0. Much of the LWD placed as part of this 2010 project (particularly those from RM 3.9 to 4.5 along the right bank channel) are not engaged during low flow conditions, as the primary or low flow channel currently occupies the left bank channel within sub-reach 6. Flow has been observed in the right bank channel near RM 4.9 during flows approximately 1,600-cfs and higher (Figure 3). It is important to note that in the upstream most sub-reach the river channel avulsed sometime between 1986 and 1994 from the left side of its valley to the right, then moved back again between 2006 and 2009 (Figure 4).

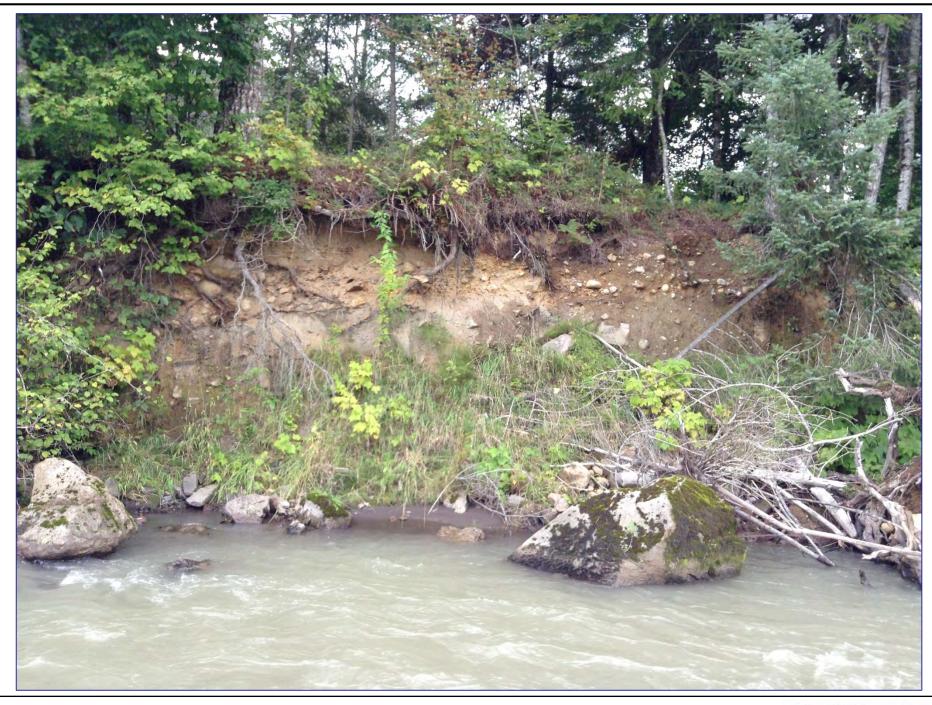
FIGURE 6 – Exposure of resistant lahar deposit along left bank at RM 0.8

thick (Dragovich et al 1997) is exposed along the Lower Middle Fork (Figure 6), and forms discontinuous erosional terraces (15- to 20-ft high) along the lower valley margins. Holocene landslide deposits mantle the lower valley margin, particularly the northeastern side. Alluvial fans are present where larger tributaries enter the valley bottom (Figure 5). The 6,000 year old lahar is most prominent at the lower end of the valley, forming a high terrace along the southwestern (left) valley from near the confluence with the North Fork (RM 0.5) up to RM 1.7, and between RM 1.4 and 3.0 on the northeastern (right) side of the valley. Locations where this lahar is exposed have restricted channel migration over the period of recent record (1890 – 2013), probably due to the high cohesion of the lahar deposits (Figure 6). This resistance to erosion has formed a geologic control in the valley that limits channel occupancy where the lahar deposits are present.

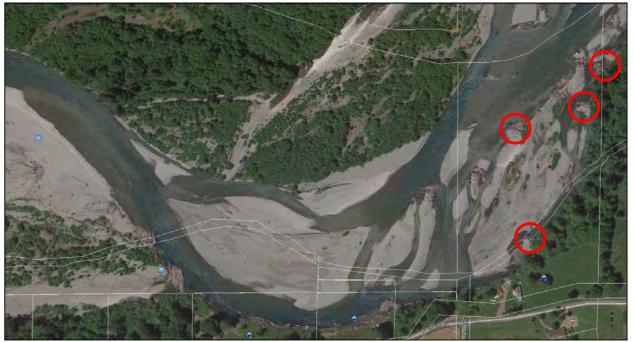
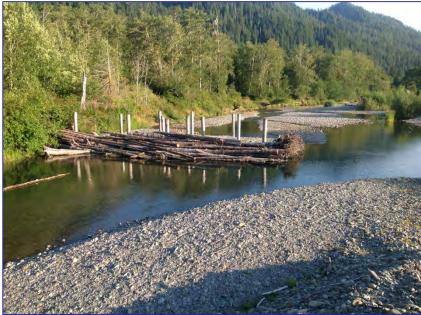
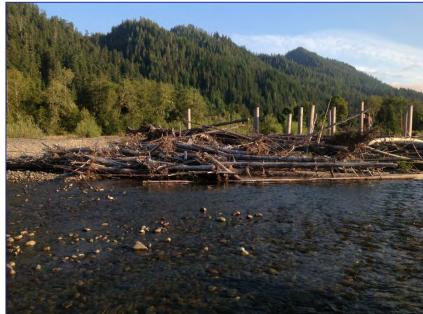
FIGURE 15 – 2013 Aerial photo (GoogleEarth) of constructed pile array ELJs on the Upper Quinault River basin (Top left); Left bank pile array ELJ constructed in 2012 (Lower left); Center channel pile array ELJ constructed in 2012 with significant newly racked mobile LWD (Lower right)

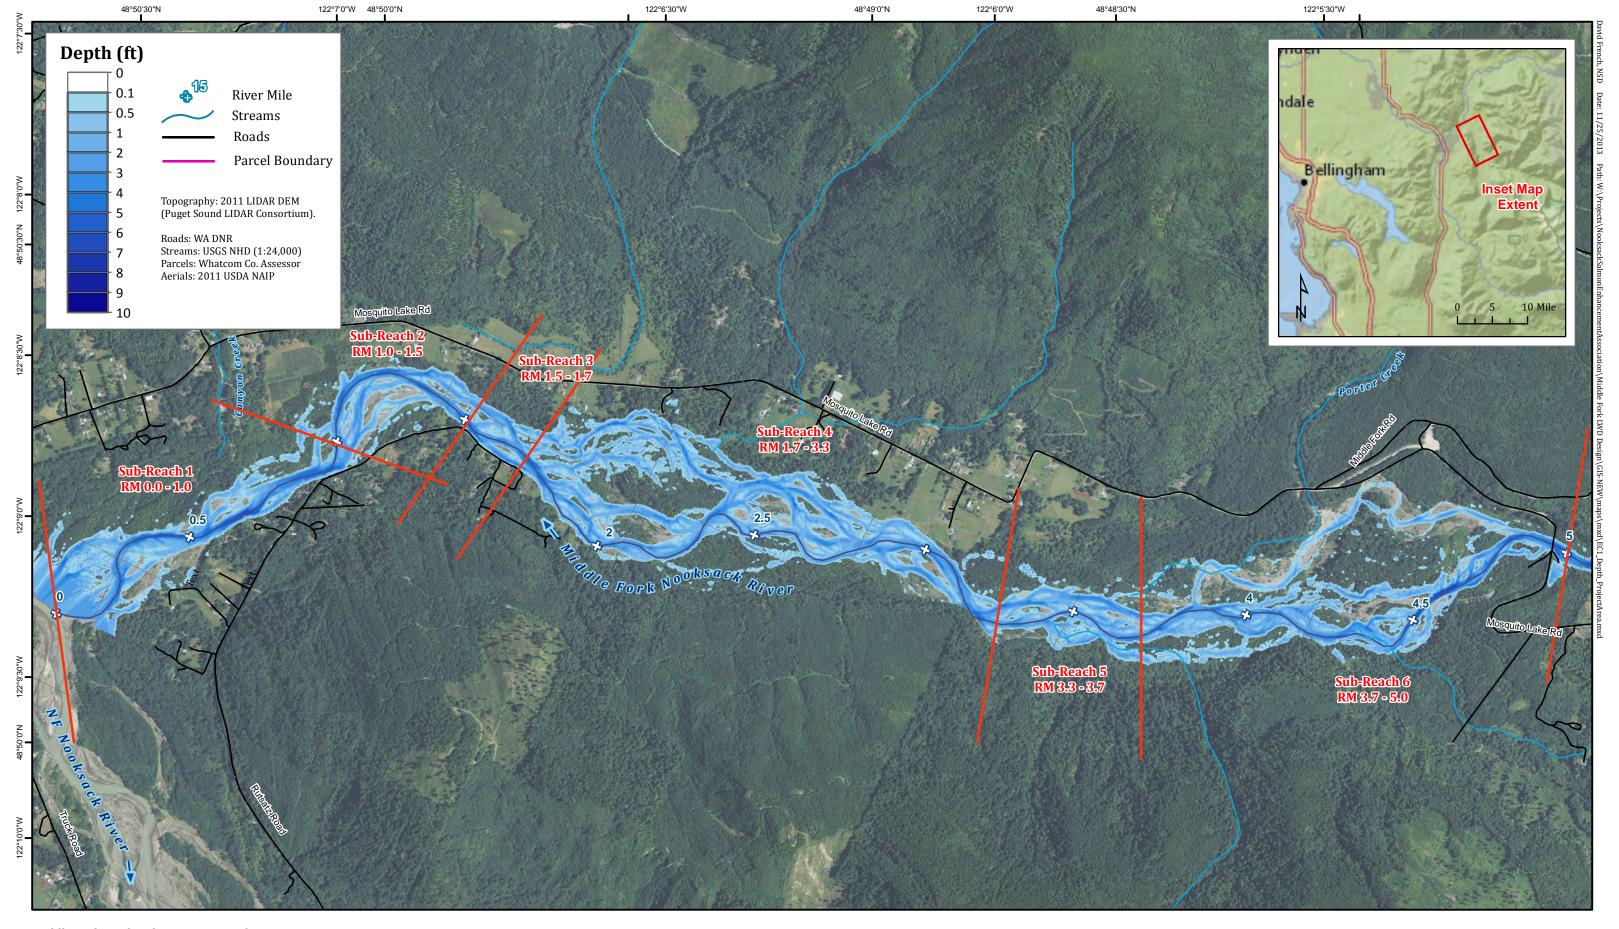
1 Year Model Output - Project Area
Existing Conditions- Depth

- The debris jam that formed at RM 4.3 following the channel avulsion at RM 4.8 is not inundated during the 1-year flow, and the old channel just upstream of the jam (where significant sedimentation was observed) is not inundated during the 100-year flow. This suggests that the left channel has incised since the channel avulsion.
- Prominent side channels through the right bank floodplain at RM 2.4 and 3,500-ft in length are activated at the 1-year peak flow. Flow depths and velocities range between 3- to 5-ft and 1- to 3-ft/s in these channels, respectively.
- A side channel through the left bank floodplain at RM 2.5 and 1,400- feet in length is activated at the
 1-year peak flow. Flow depths and velocities range between 1- to 3-ft and 0.5- to 1-ft/s in these channels,
 respectively.

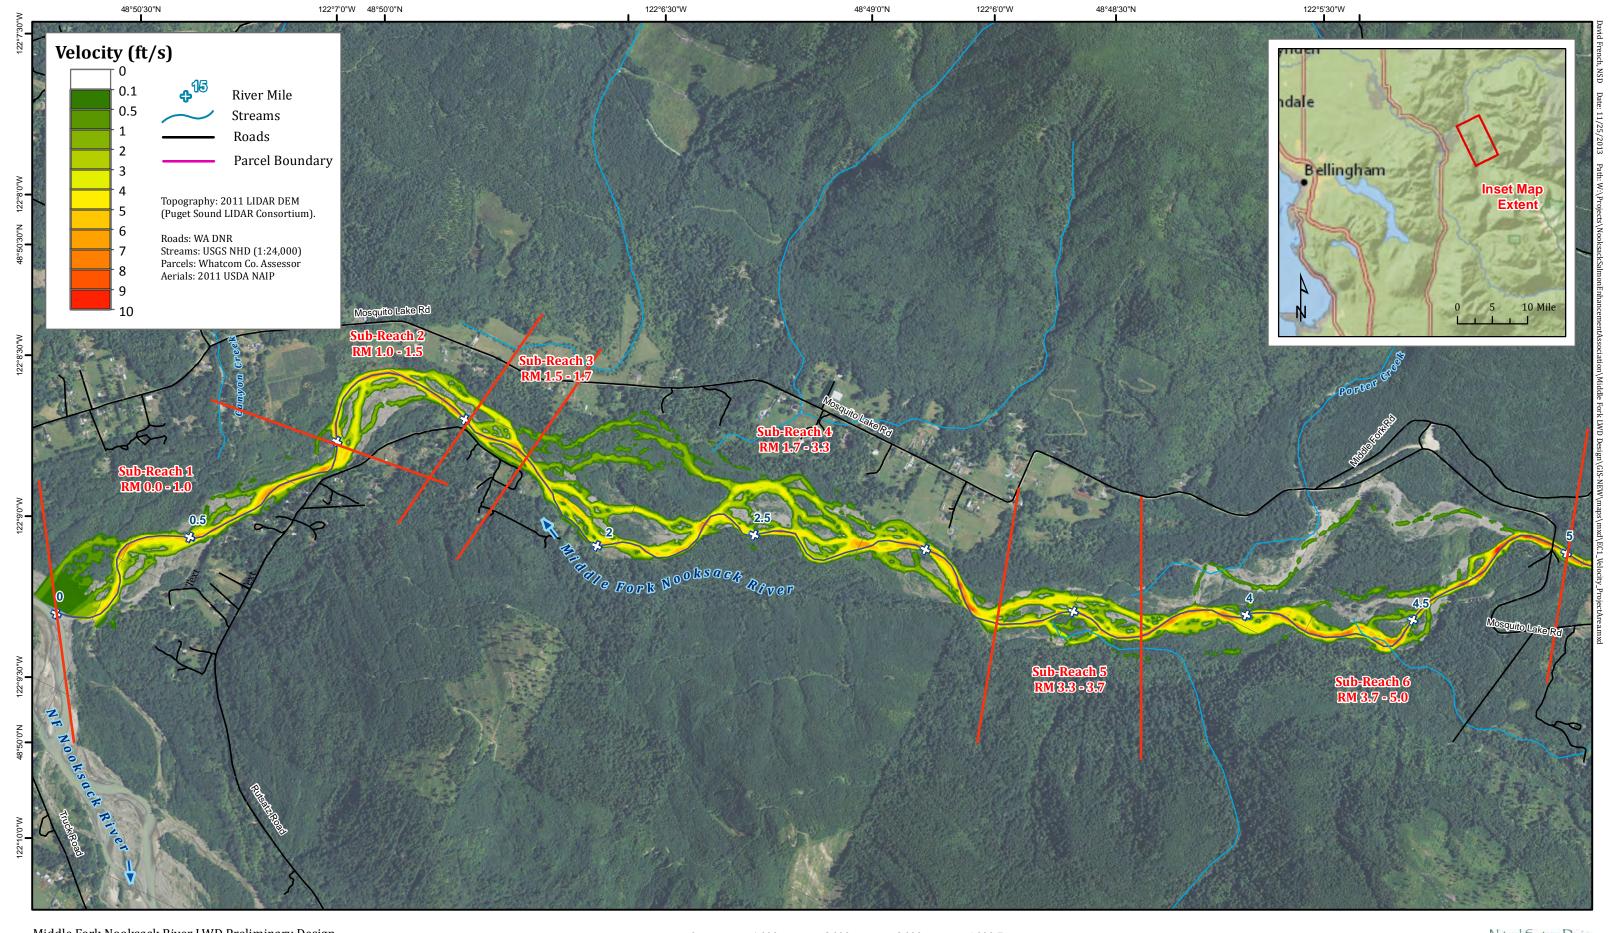
1 Year Model Output - Project Area

Existing Conditions- Velocity

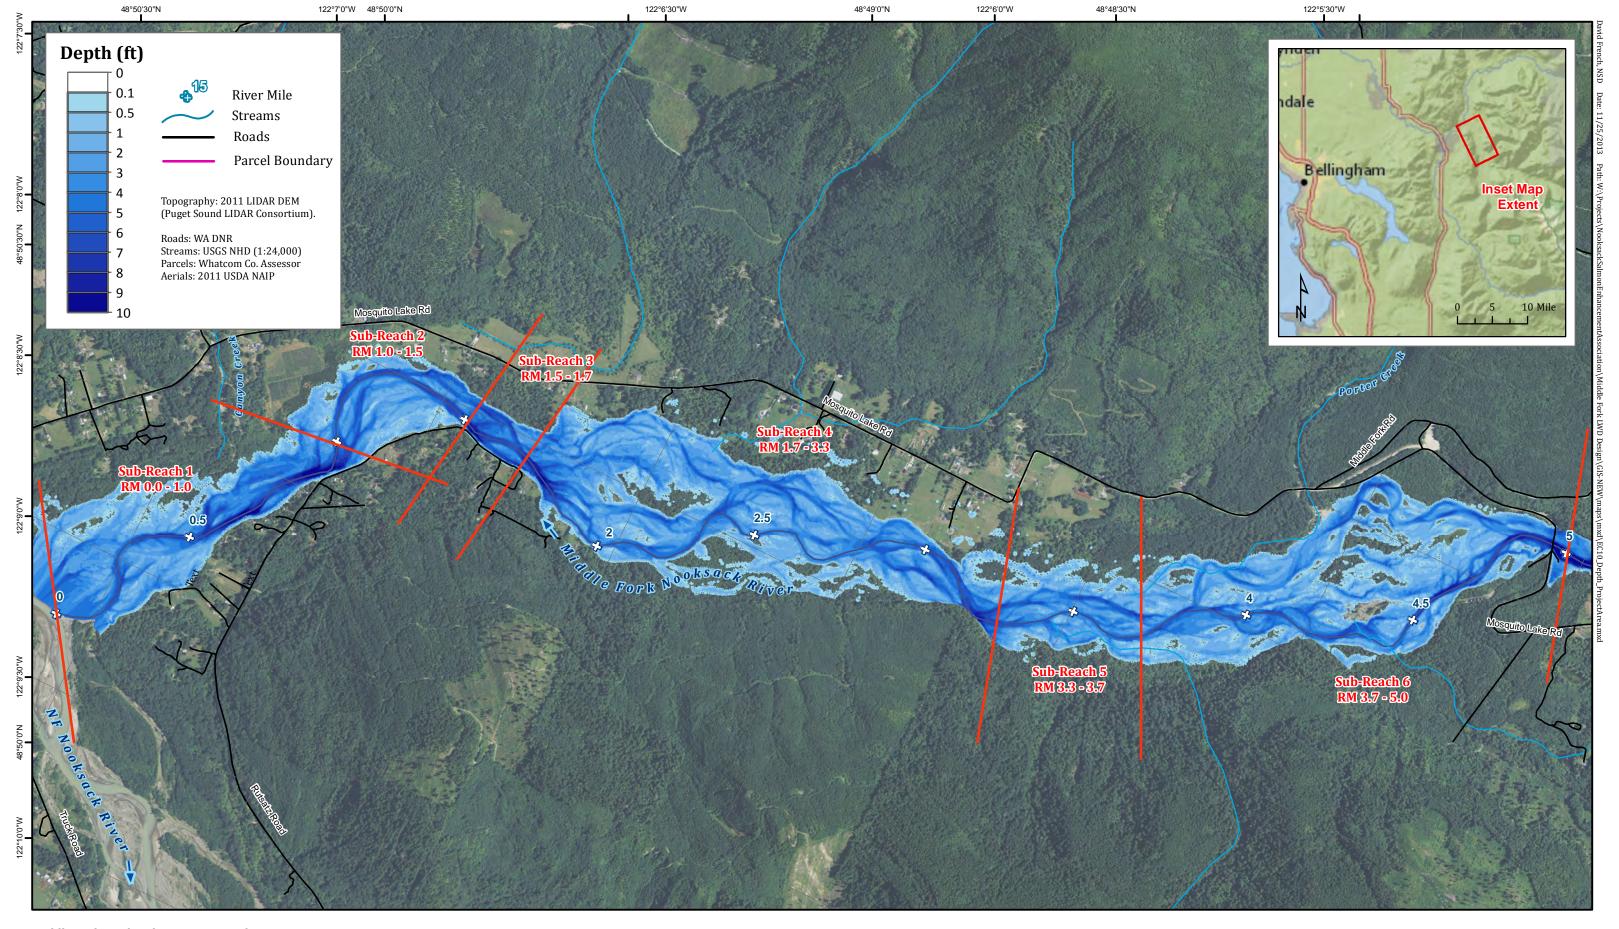
Middle Fork Nooksack River LWD Preliminary Design
10 Year Model Output - Project Area

Existing Conditions- Depth

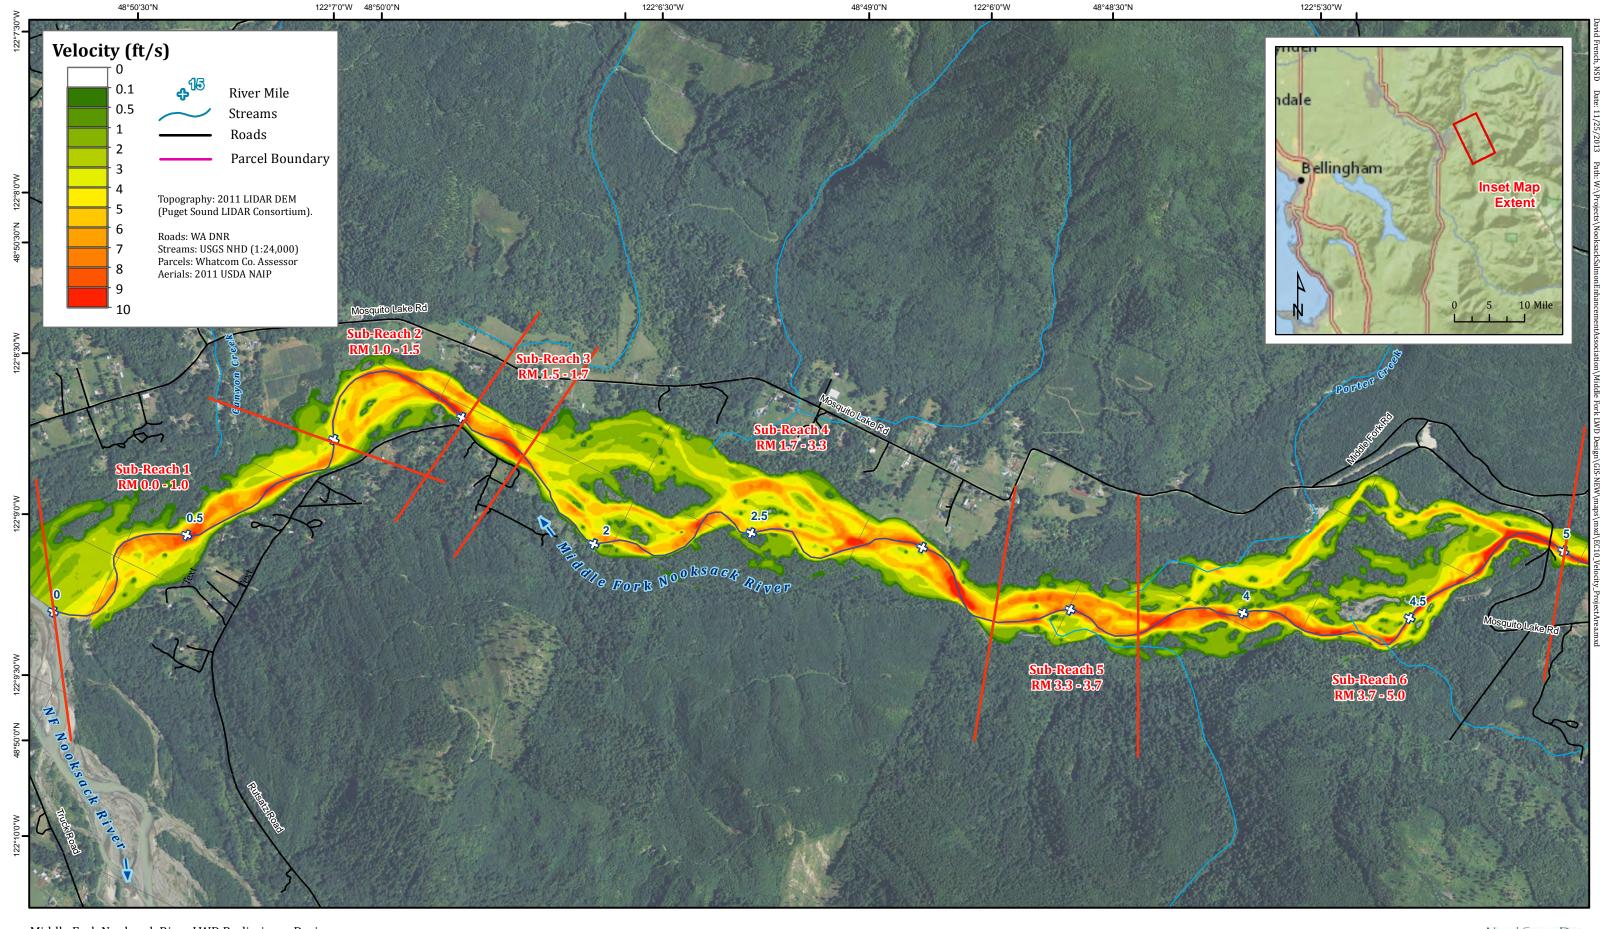
Middle Fork Nooksack River LWD Preliminary Design
10 Year Model Output - Project Area
Existing Conditions- Velocity

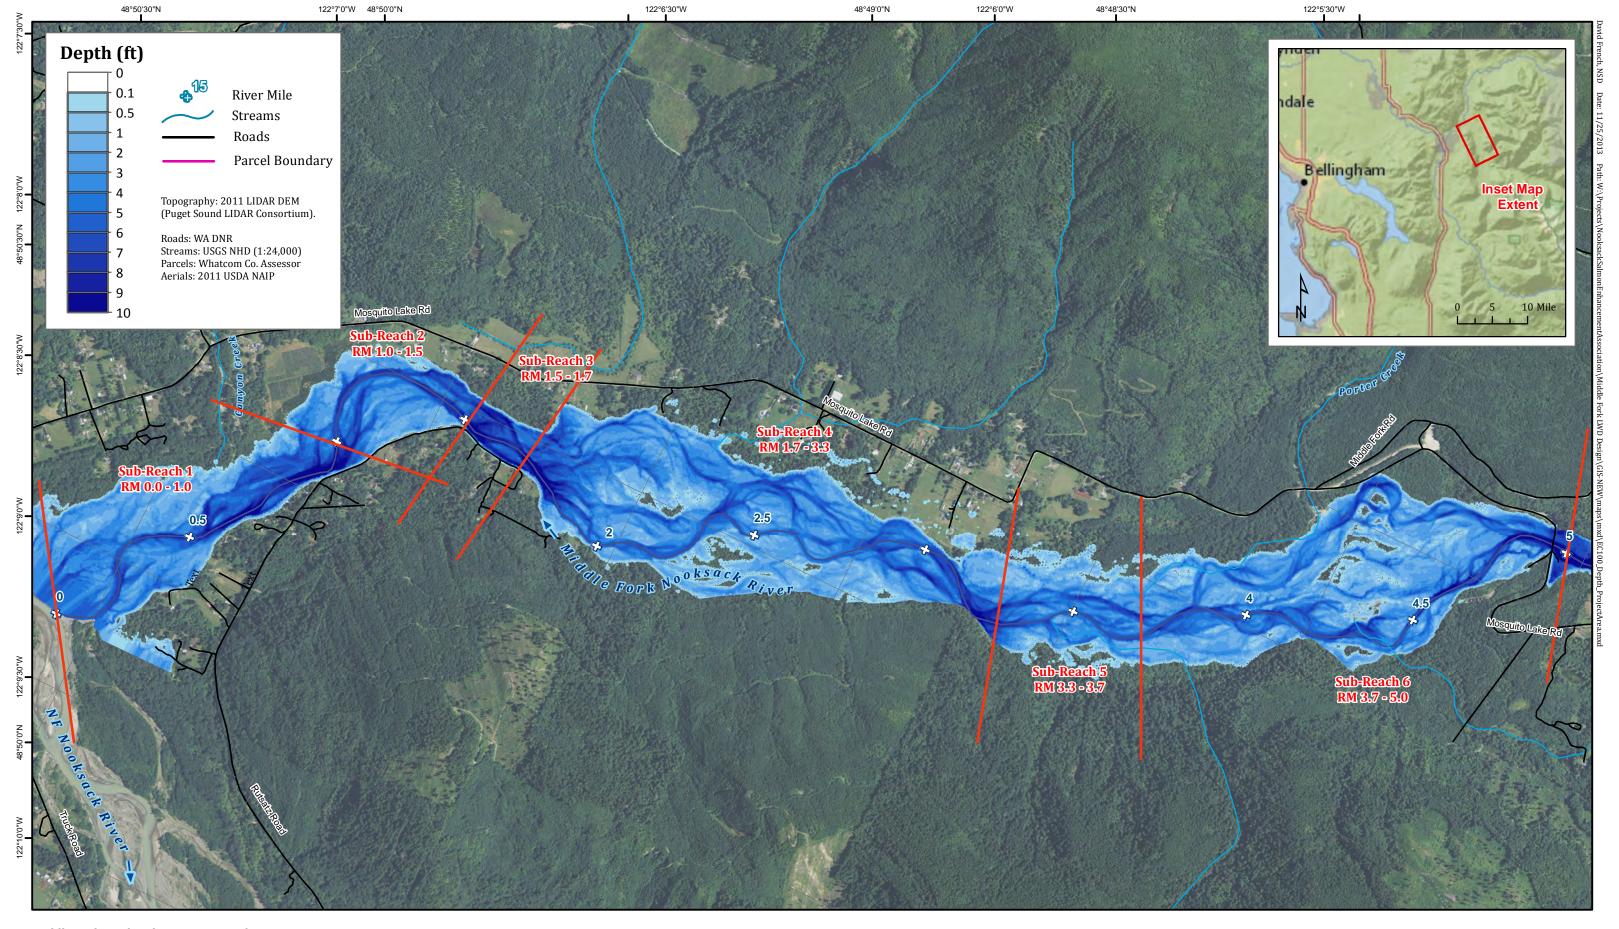
Middle Fork Nooksack River LWD Preliminary Design 100 Year Model Output - Project Area Existing Conditions- Depth

- The degree that underlying geologic conditions affect riverine hydraulic conditions is dependent on the magnitude of the peak flow event. For instance, during the 100-year peak flow the effects are pronounced due to the degree of constriction in confined sub-reaches relative to the unconfined flow width and during the 1-year peak flow the effects are less due to the smaller degree of constriction.

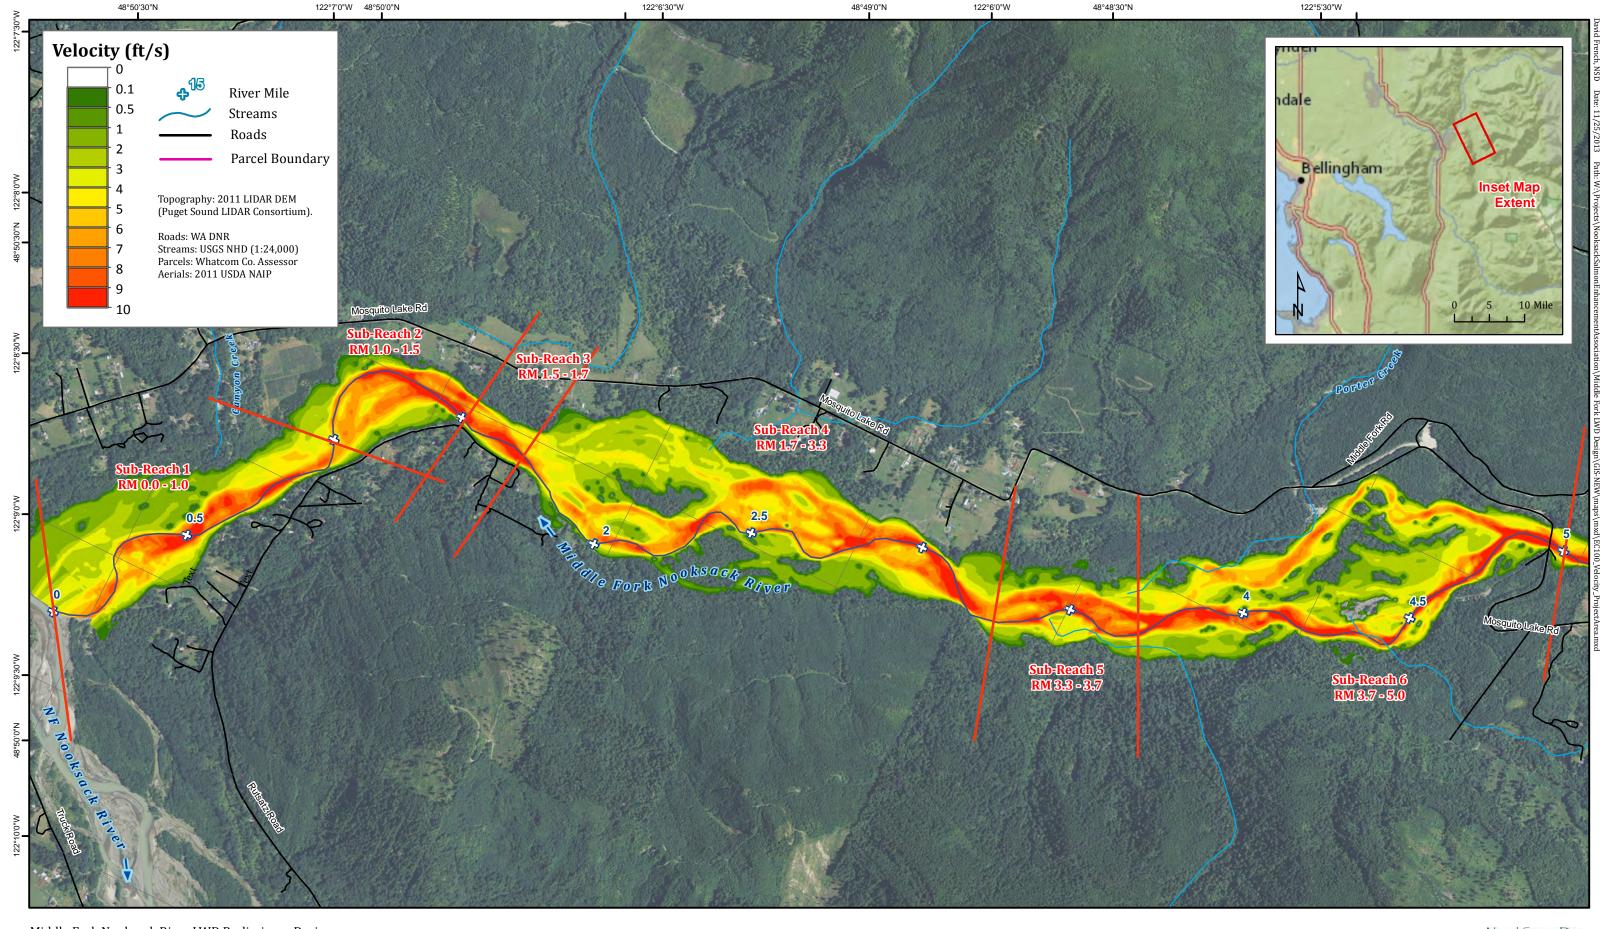
Middle Fork Nooksack River LWD Preliminary Design 100 Year Model Output - Project Area Existing Conditions- Velocity

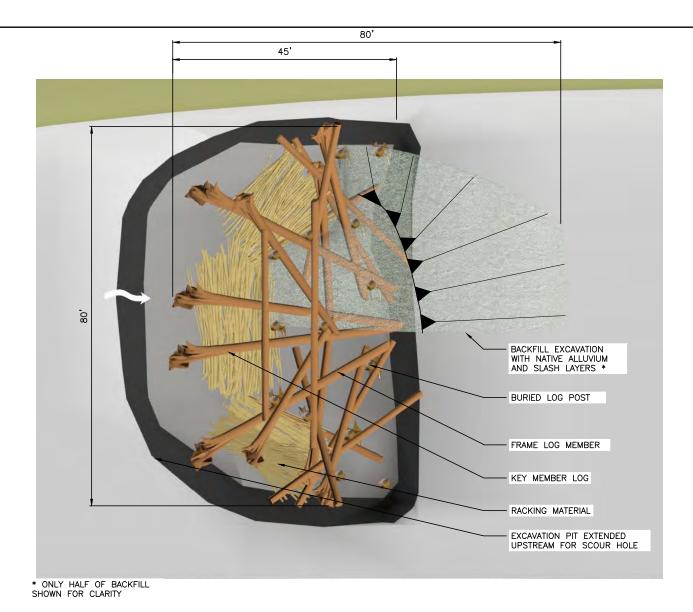
TYPE 1 ELJ PLAN

- 7. COVER TOP OF BACKFILL AREA AND BASE OF STRUCTURES 6-12 INCHES WITH LOOSE WOOD DEBRIS AND CHIPS.
- 8. CABLE FRAME LOG MEMBERS PER INSTRUCTIONS ON LAYERING PLAN TO VERTICAL POSTS WITH 1/2 INCH GALVANIZED STEEL CABLE AND 4 CABLE CLAMPS PER LASHING. STAPLES WILL NOT BE USED TO FASTEN CABLE ENDS TOGETHER. ALL
